August 30, 2004

RÜTGERS Organics Corporation

**RE: RESPONSE TO SPILL INCIDENT NOV DATED JULY 27, 2004 –
NEASE SITE, SALEM, OHIO**

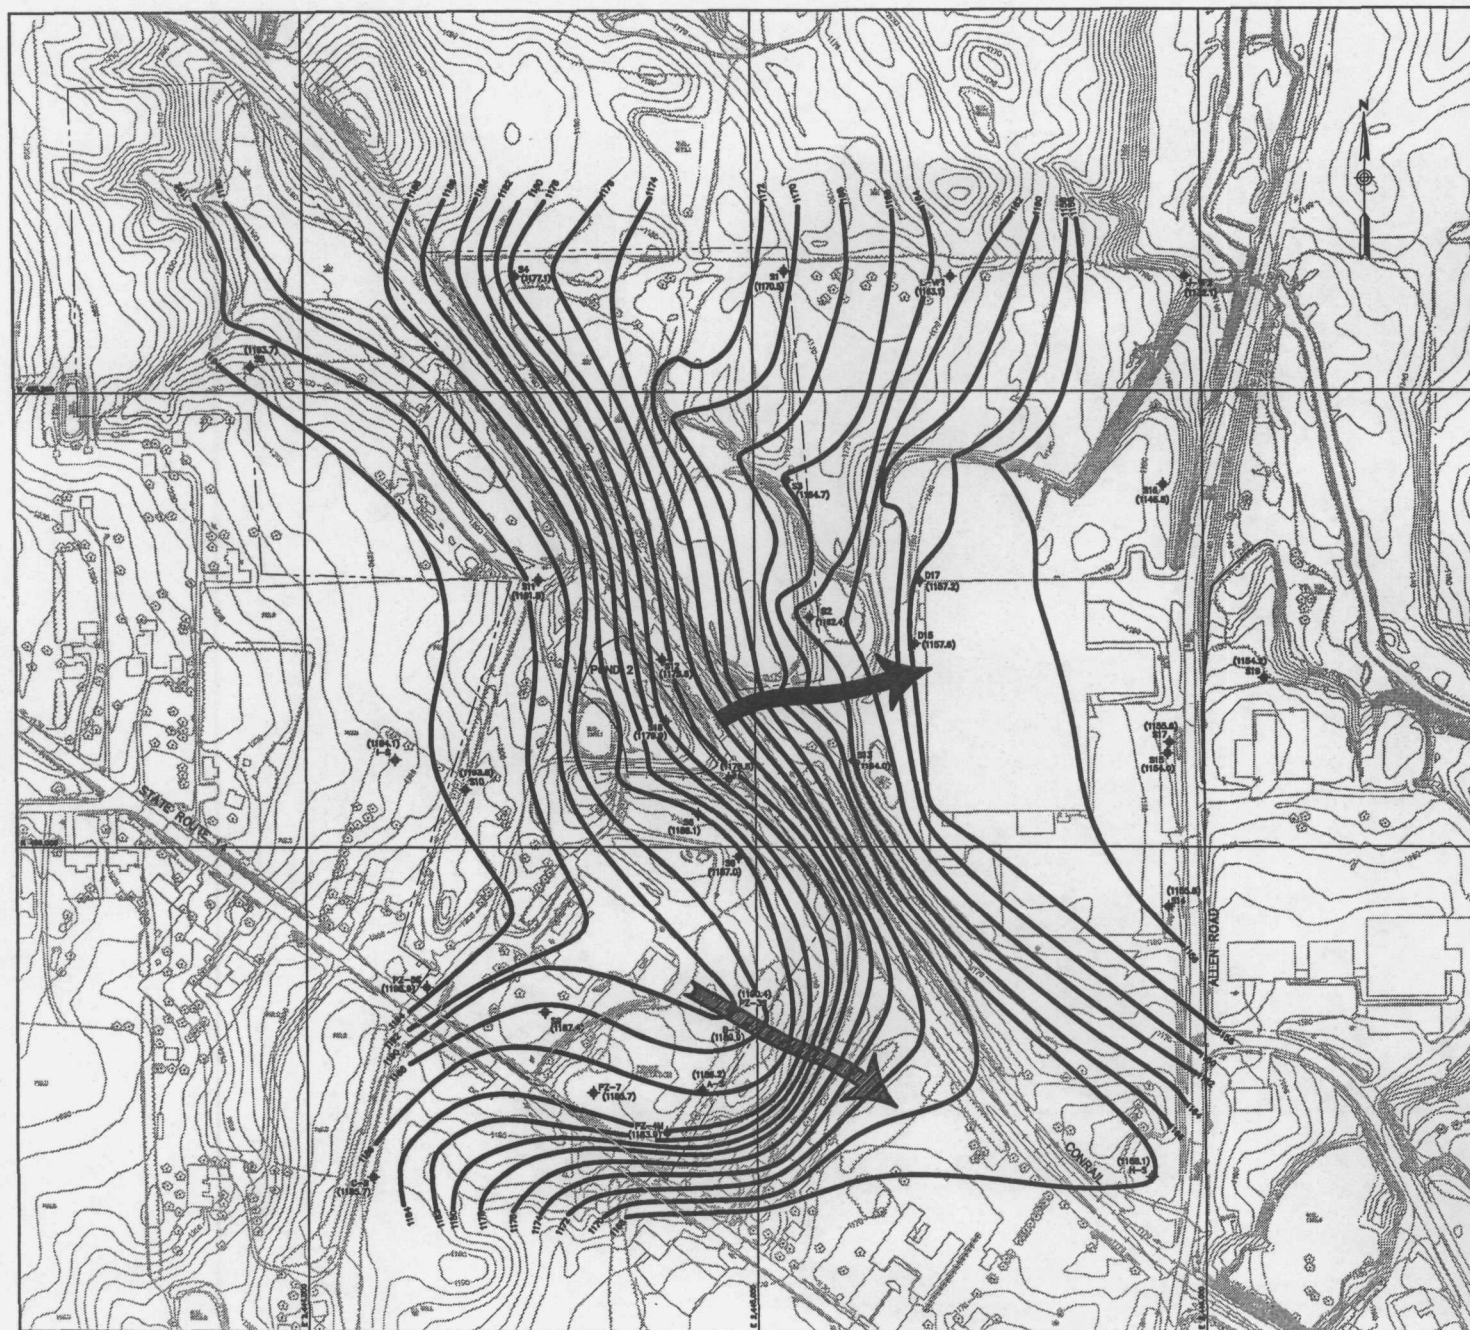
As has been previously been reported, the location of the treatment plant building is upgradient of the groundwater extraction system. Referring to the groundwater potentiometric contour map presented in Figure 2 of the Eastern Plume / DNAPL Investigation Report (see Attachment 2), the treatment plant is located on a groundwater divide, and the shallow groundwater flow in the area of the treatment plant building could flow in two different directions. As described in the Investigation Report text, the primary flow regime is toward the east/northeast where the collection system is located, and a second, less significant, regime is towards the south/southeast. The transition between the two flow directions is near the treatment plant building.

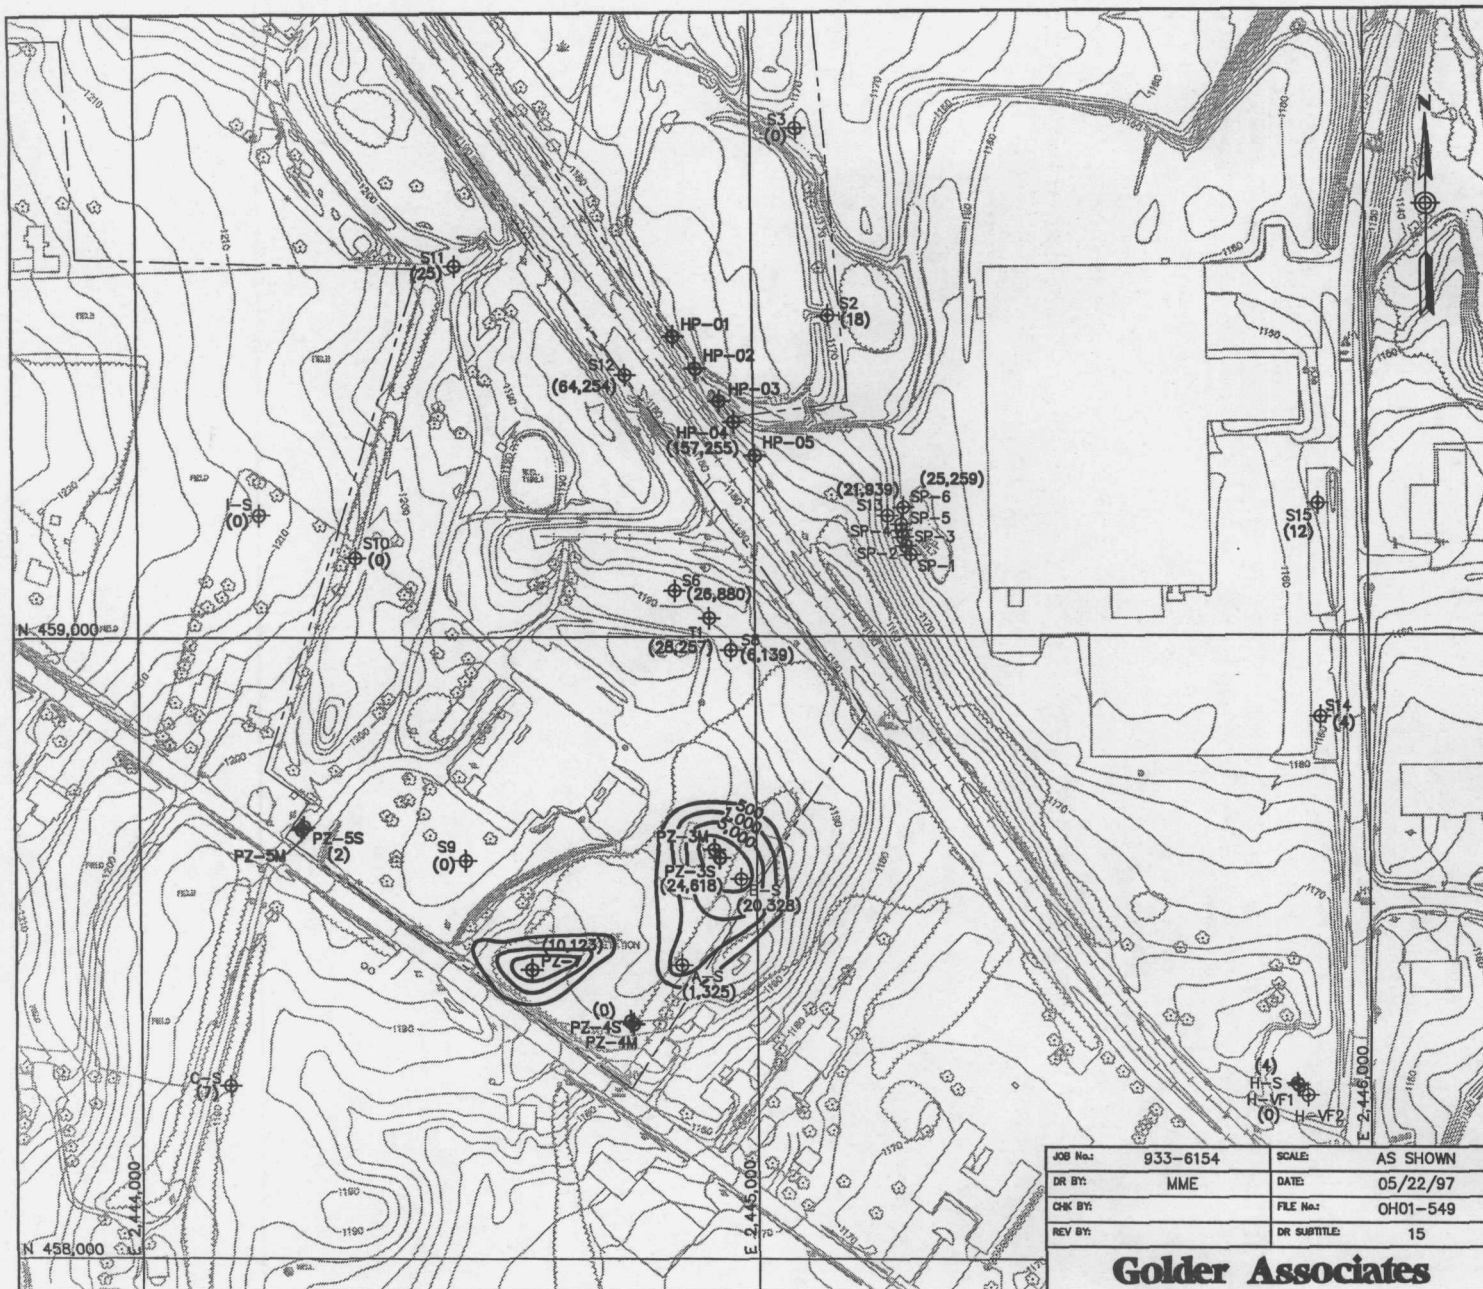
FIGURE 11

The Eastern Plume / DNAPL Investigation Report also identified existing VOC and SVOC impacts to shallow groundwater to the south and southeast of the treatment plant building, as showing in Figure 11 (see Attachment 3). The contaminants identified in the groundwater to east/northeast and south/southeast of the treatment plant are chlorinated

organics nearly identical to those detected in the analysis of spilled influent. Remediation of both areas of the groundwater is already being addressed as part of the on-going Feasibility Study (FS) for the Site.

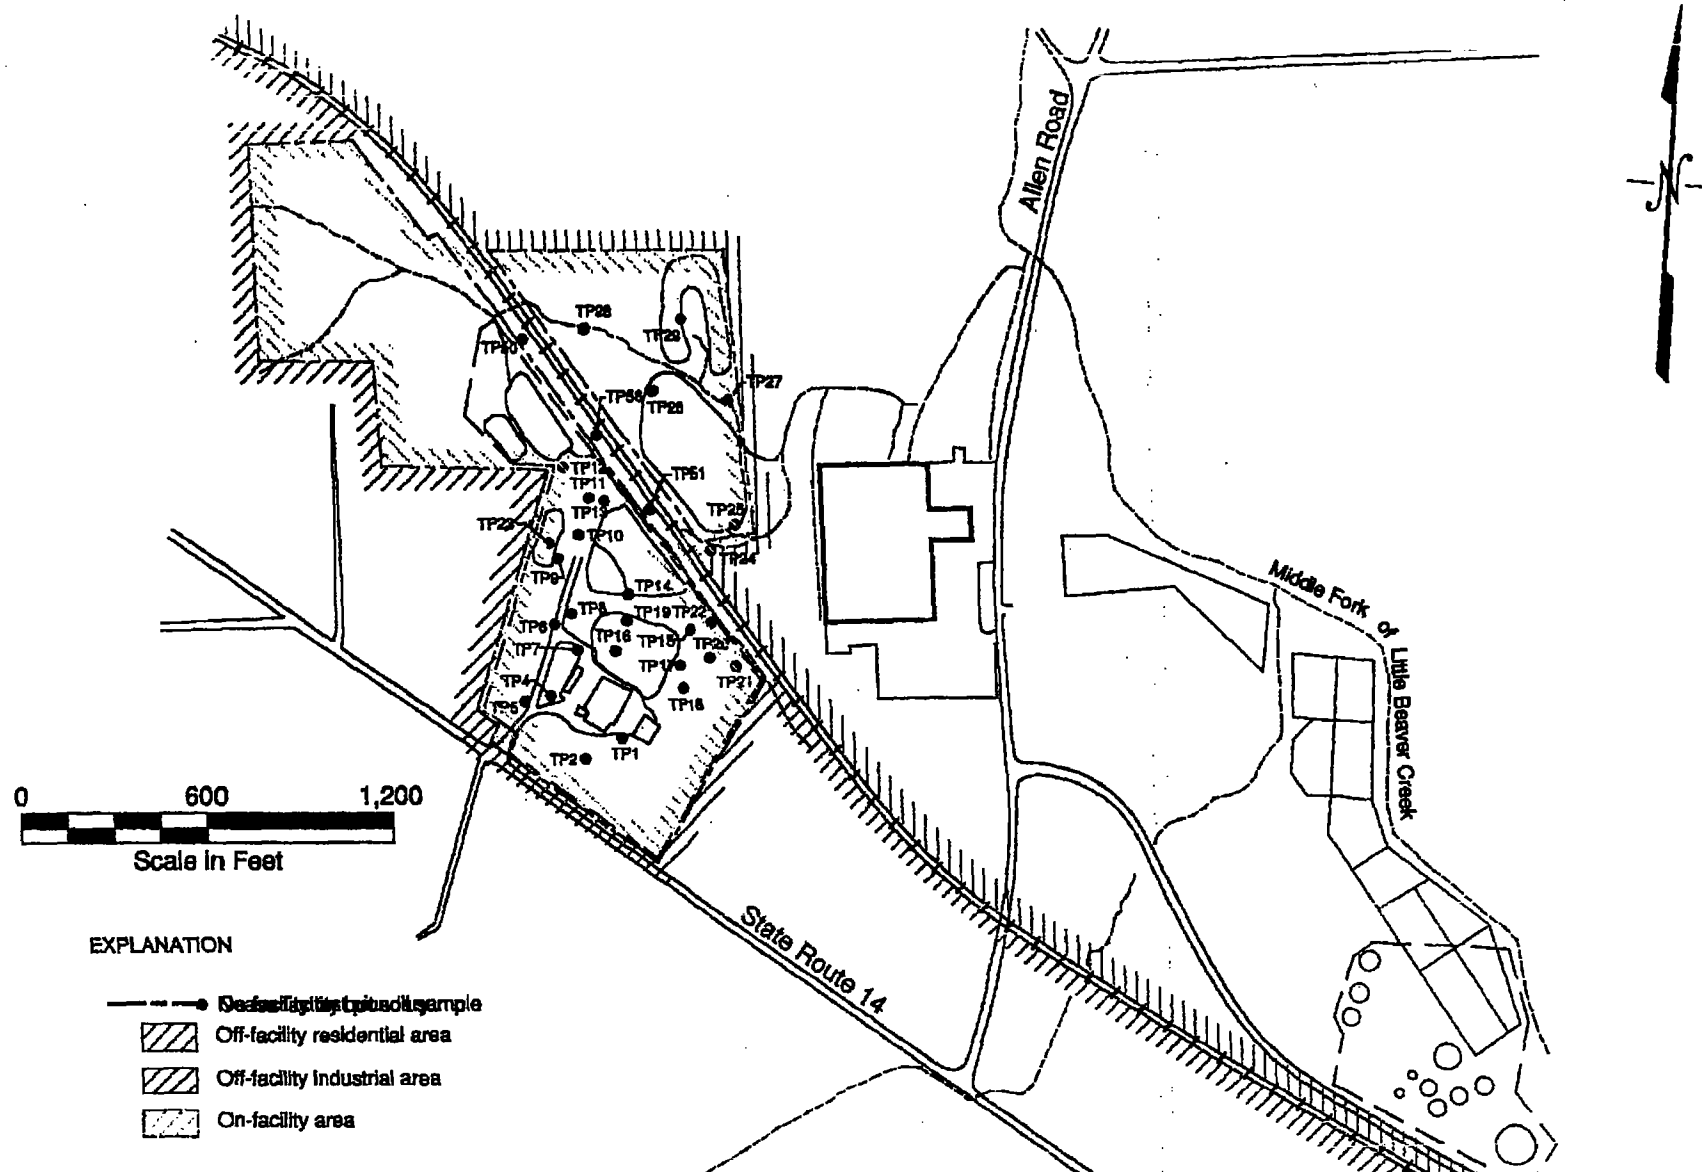
Figure
III-5

Soil sampling data showing the extent of soil contamination at the Site has previously been provided to OEPA in the Remedial Investigation (RI) Report (November 1993). In particular, the test pit sample TP1 located closest to the spill area shows that the soil already was contaminated by chlorinated organics and mirex, including organics detected in the analysis of the spilled water.

Attachment 4 provides a map showing the soil boring locations and a summary table of detections found at the locations closest to the treatment plant building, including TP1, TP2, and TP18.

Remediation of the on-Site soils, including the area around the treatment plant building, already is being addressed as part of the ongoing FS for the Site.
